REPORT NO. 3588

SOUTHERN PACIFIC COMPANY

IN RE ACCIDENT

AUGUST 26, 1954

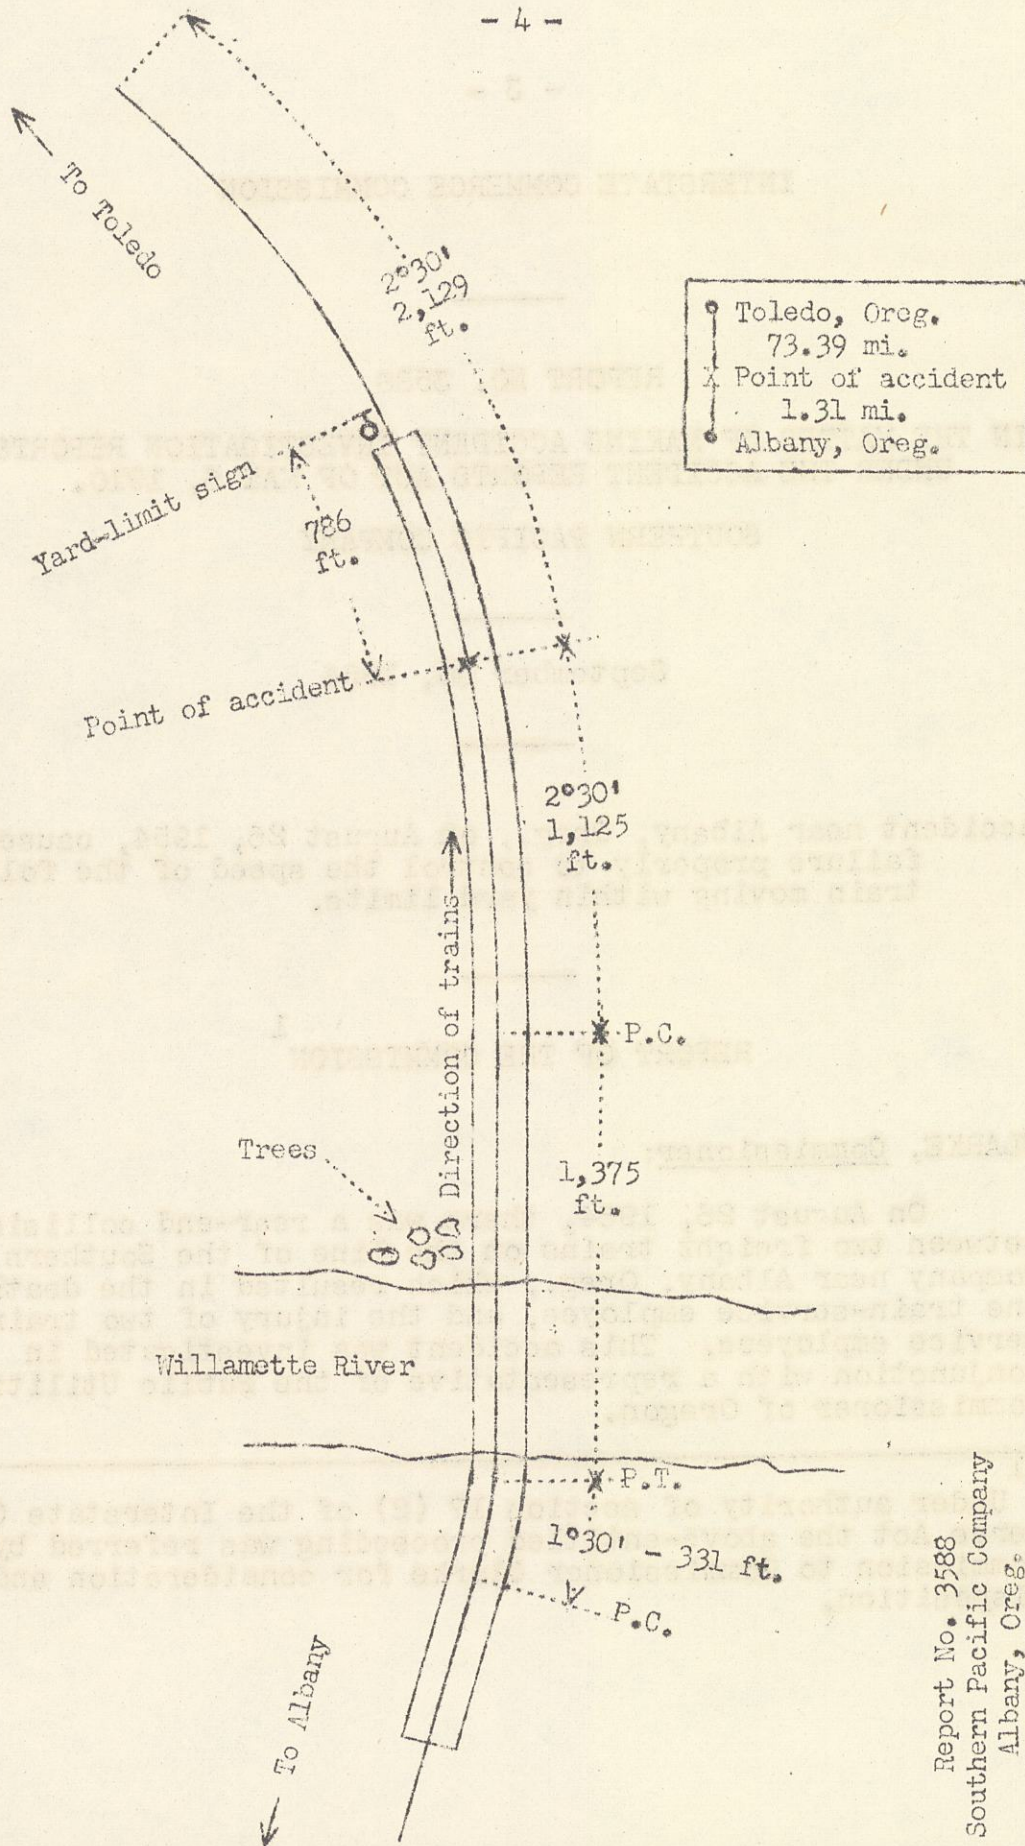
This accident occurred on that part of the Portland Division extending between Albany and Toledo, Oreg., 74.7 miles, a single-track line, over which trains are operated by timetable and train orders. There is no block system in use. The accident occurred on the main track within yard limits at a point 1.31 miles east of the station at Albany and 786 feet west of the east yard-limit sign. From the west there are, in succession, a 1°30' curve to the left 331 feet in length, a tangent 1,375 feet, and a 2°30' curve to the left 1,125 feet to the point of accident and 2,129 feet westward. The grade is 0.76 percent descending eastward at the point of accident.

East of the station at Albany the railroad crosses the Willamette River on Bridge 691.65. This bridge consists of a 260-foot center Howe truss draw span flanked by two 140-foot through Howe truss spans. The west approach consists of an 820-foot open-deck pile trestle, and the east approach consists of a 2,542-foot open-deck pile trestle. There are no walkways or railings on the trestles except at refuge bays. The accident occurred on the east approach to the bridge at a point 2,291 feet east of the center of the draw span. At this point the top of the trestle is 21.3 feet above the level of the ground.

No. 706 stopped with the front of the locomotive 141 feet east of the point of accident. The front end of the locomotive was considerably damaged. The eighth car of Extra 5228 East dropped to the ground on the south side of the trestle. The rear end of the frame of the seventh car overrode the front platform of the caboose, passed completely through the caboose, and penetrated the front end of the locomotive of No. 706 to a depth of 18 inches. The third, fourth, and sixth

cars were either derailed or off center. The center sills of the first, third, fourth, fifth, and sixth cars were bent; the rear end of the seventh car was damaged; and the eighth car and the caboose were destroyed.
